## **MEMORANDUM**

**SUBJECT:** Water Level Report for Pahvant Valley Wells

## **PAHVANT VALLEY WATER LEVEL PATTERN**

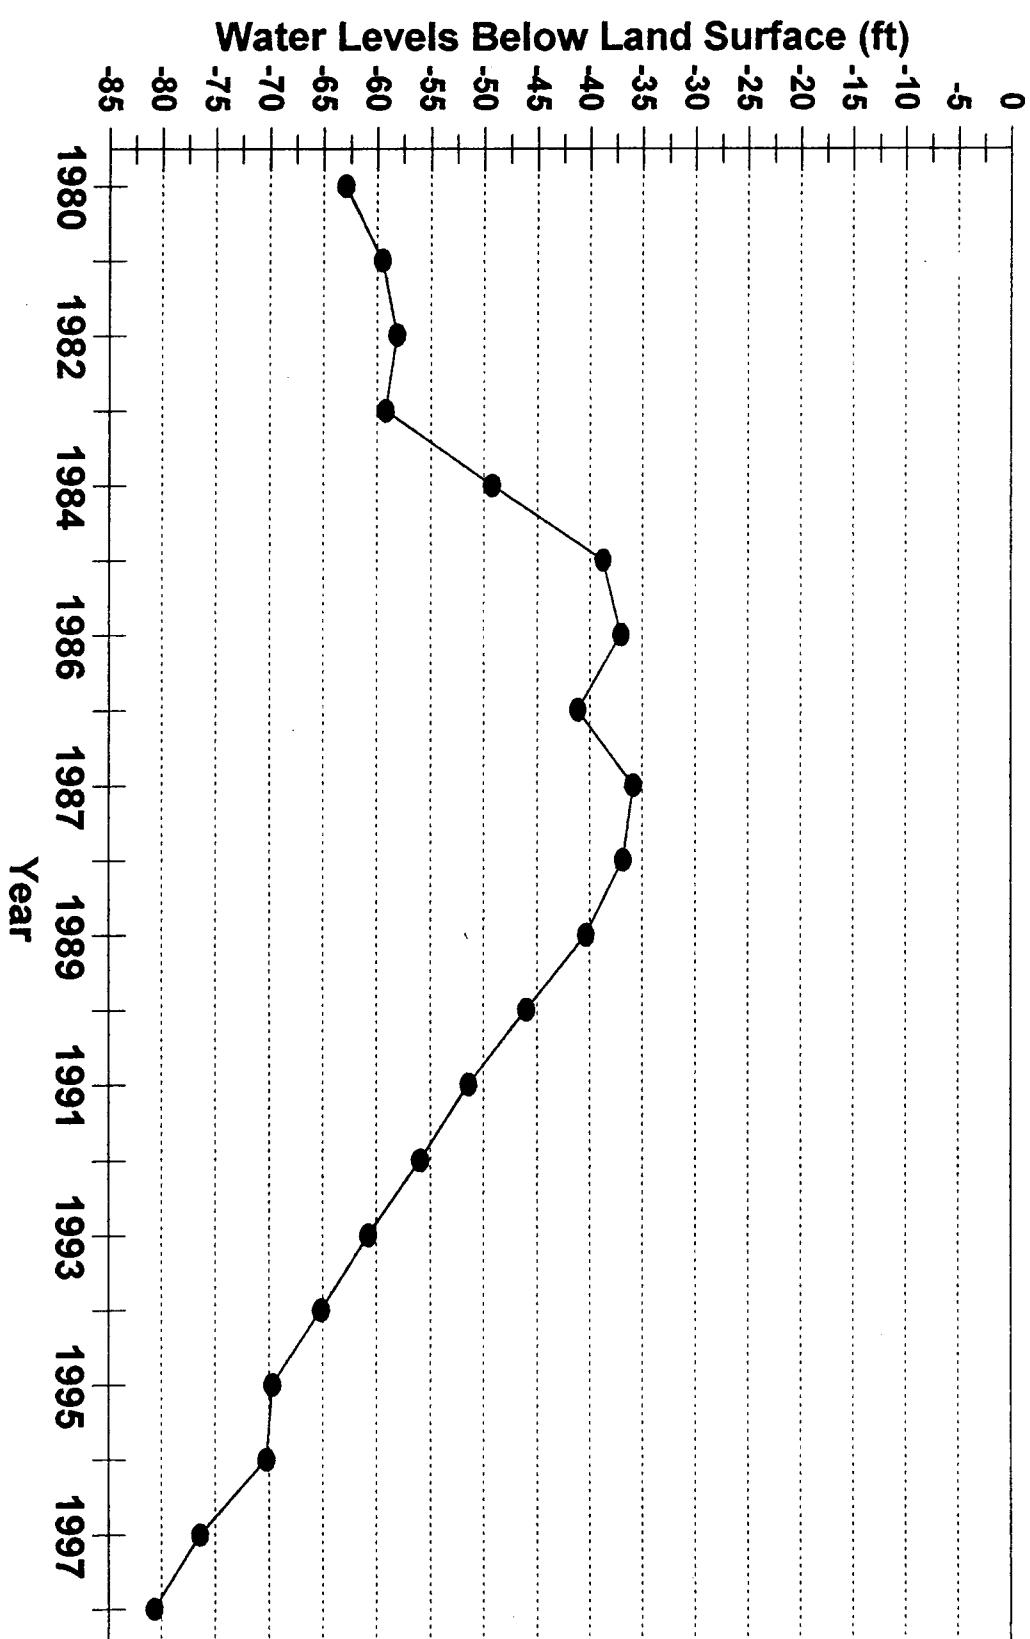
Well (C-18-5)28dda1 - #4

# Pahvant Valley Ground Water Levels

Water level measurements in Pahvant Valley in the spring of 1999 are generally higher than those measured in the spring of 1998. One area of exception is the northern part of Pahvant Valley near McCornick and Hoden. Water levels in wells (C-18-5)28dda-1, (C-19-4)30dab-1, (C-19-5)2aad-1, and (C-20-5)24bad-2 decreased an average of 3 ft from 1998 levels. The lowest decline in water level (5.13 ft) was registered in well (C-20-5)24bad-2 located 7 miles Southwest of Holden.

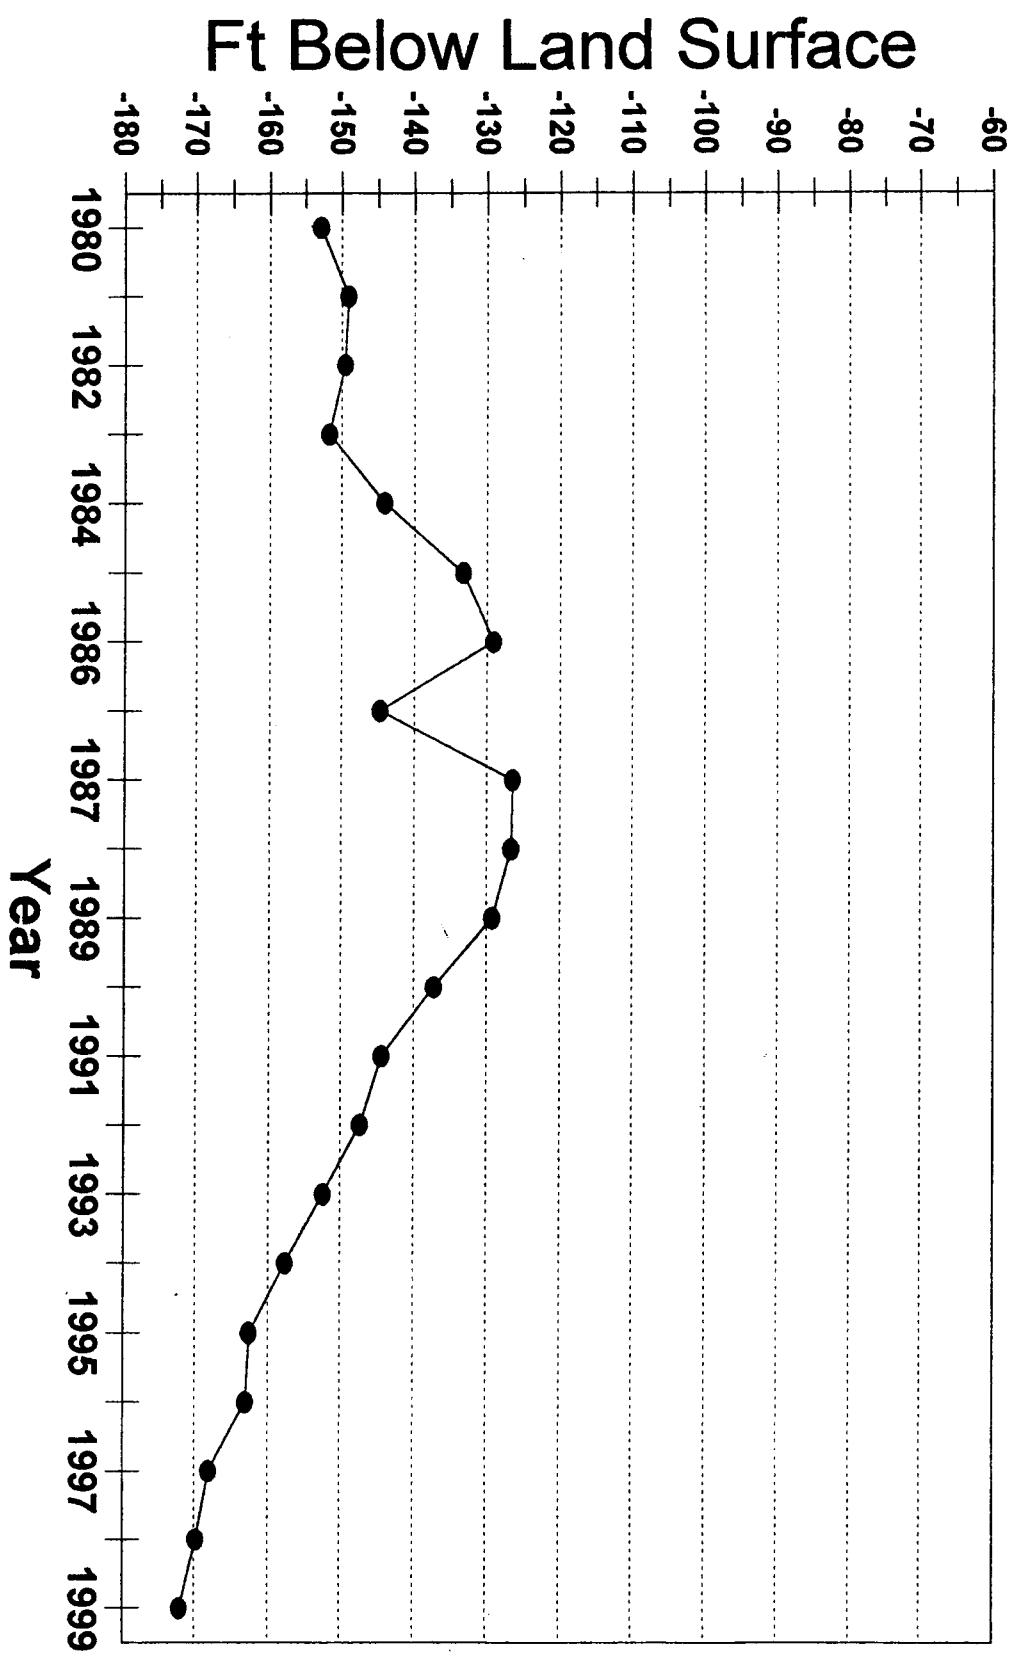
Well (C-19-4)30dab-1 #10

# Pahvant Valley Ground Water Levels

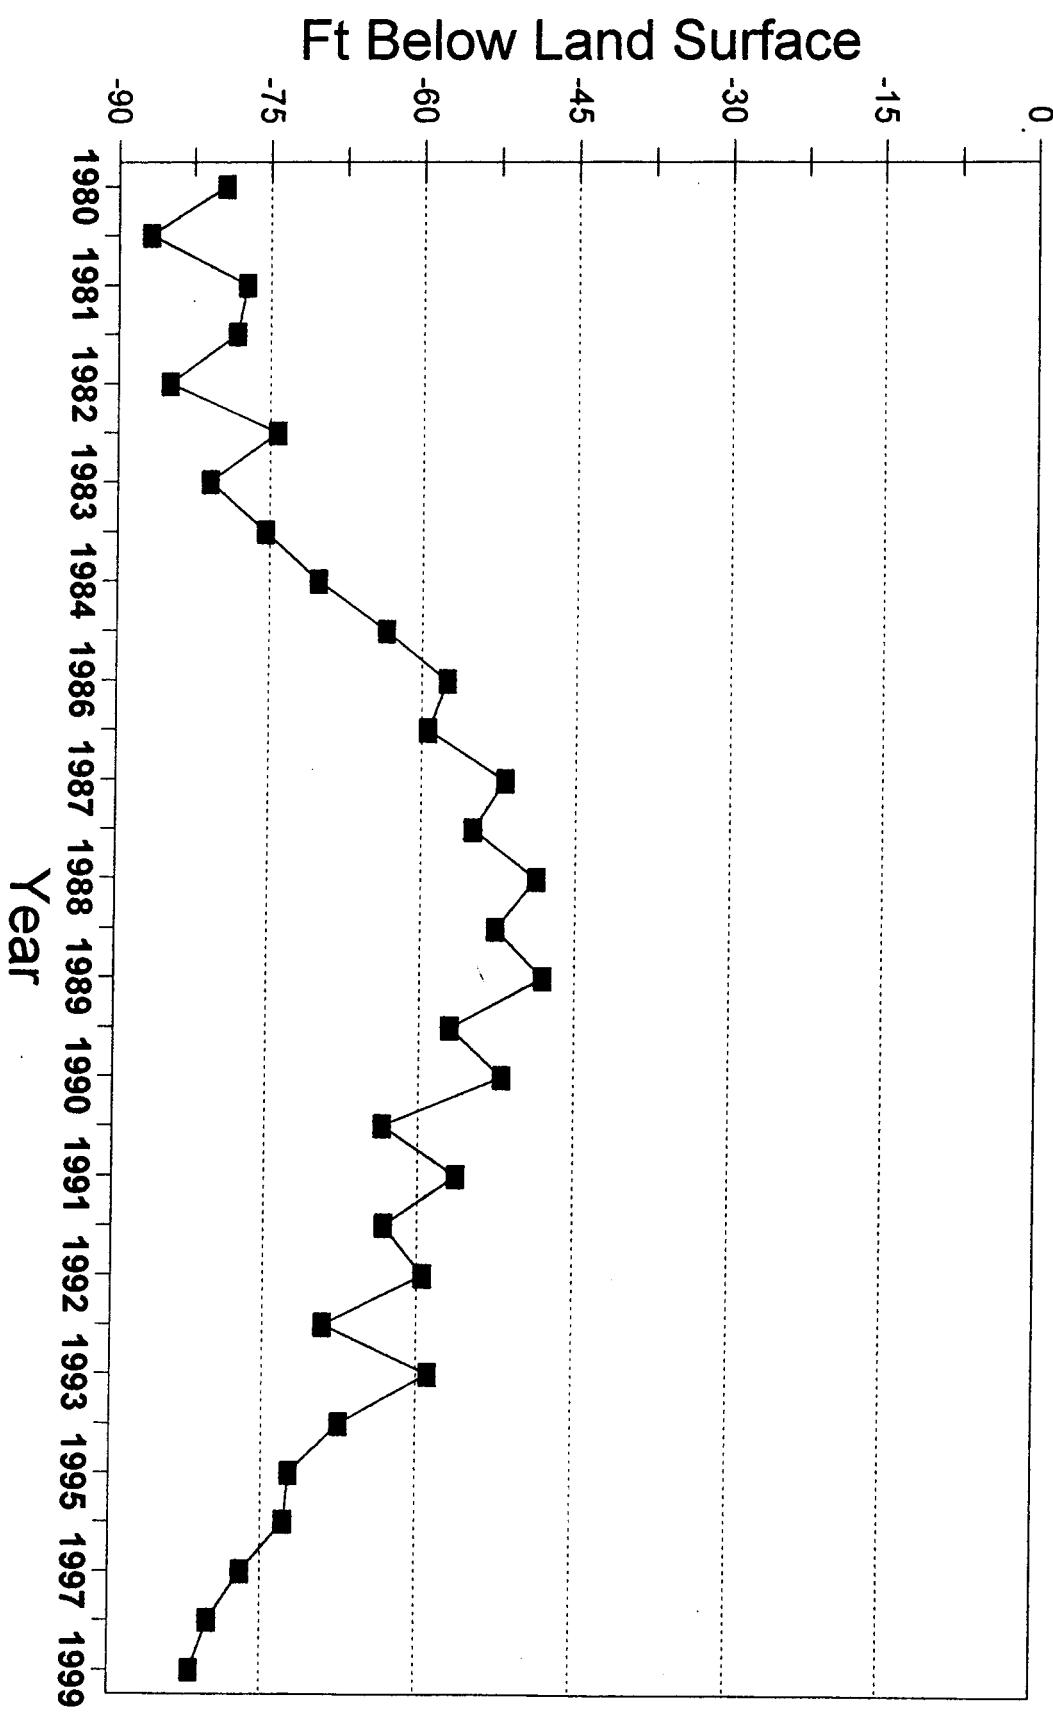
Well (C-19-5)2aad-1 - #14

# Pahvant Valley Ground Water Levels

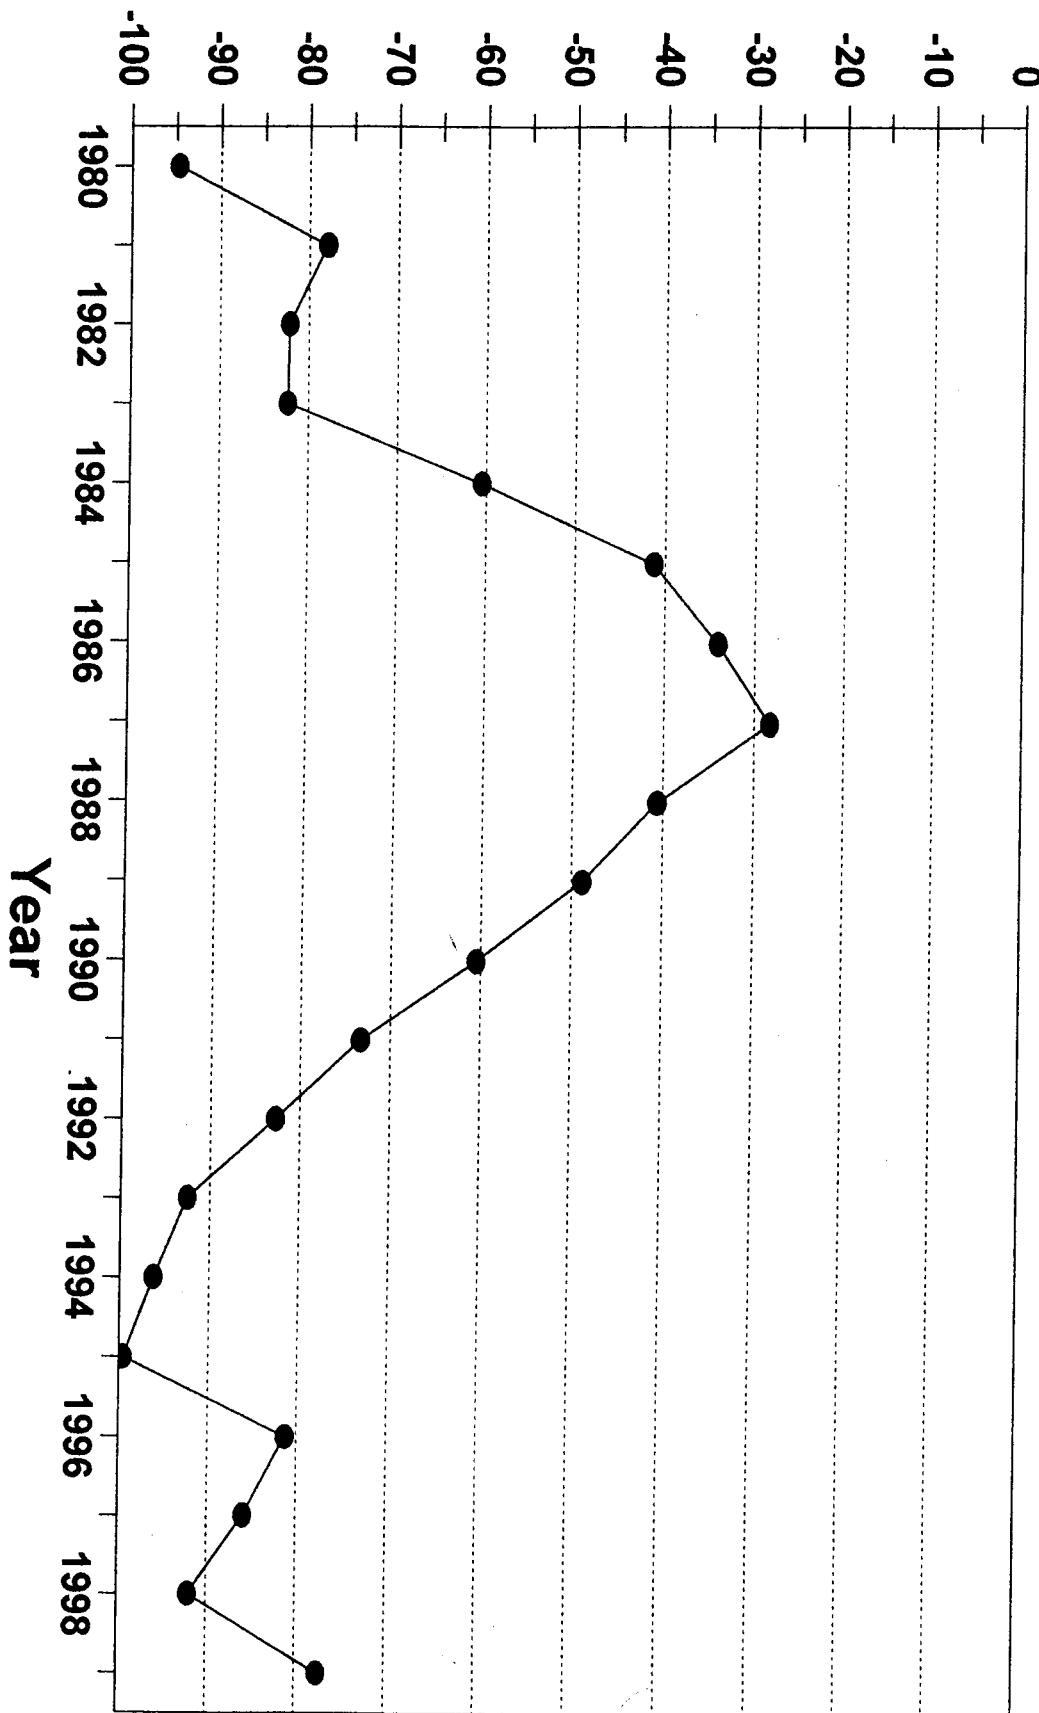
Well (C-20-4)4dab-1 #18

# Pahvant Valley Ground Water Levels

Ft Below Land Surface

Overall, in the majority of wells the water table has increased for the last two years. Seven wells out of the 13 in the study area, show an increase in water levels from the spring of 1998 to the spring of 1999. Well (C-20-4)4dab-1 registered the largest increased in water levels (14.4 ft) over the 1998 levels.

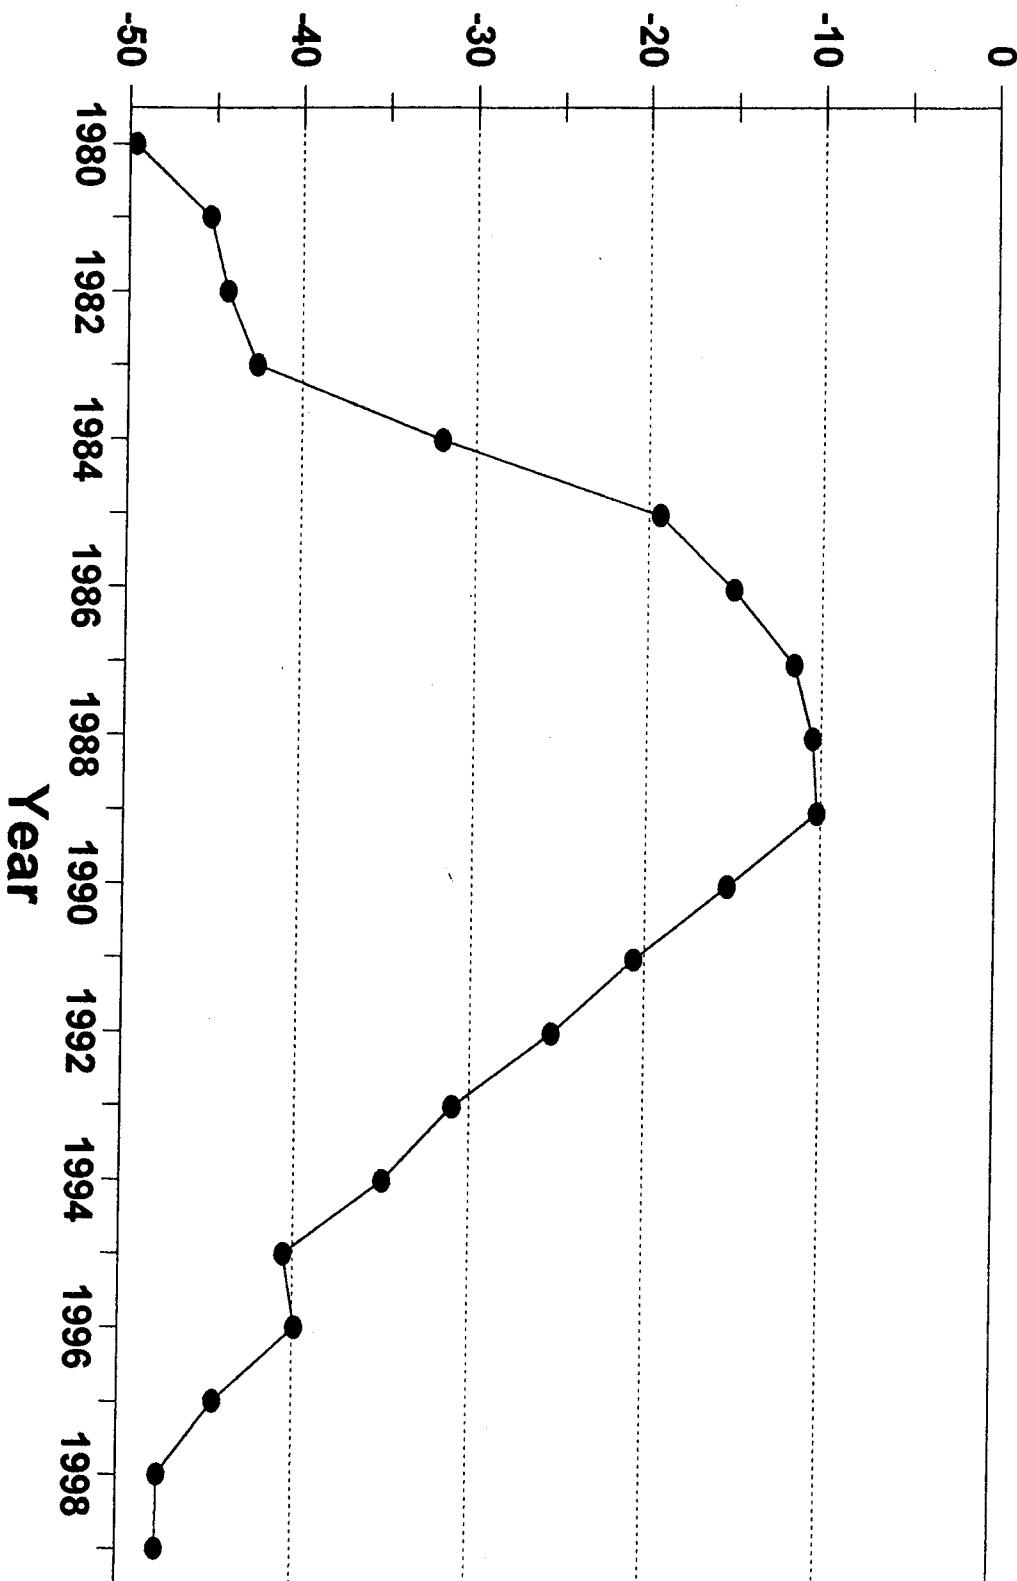
Well (C-20-4)6dbc-1 #20

# Pahvant Valley Ground Water Levels

Ft Below Land Surface

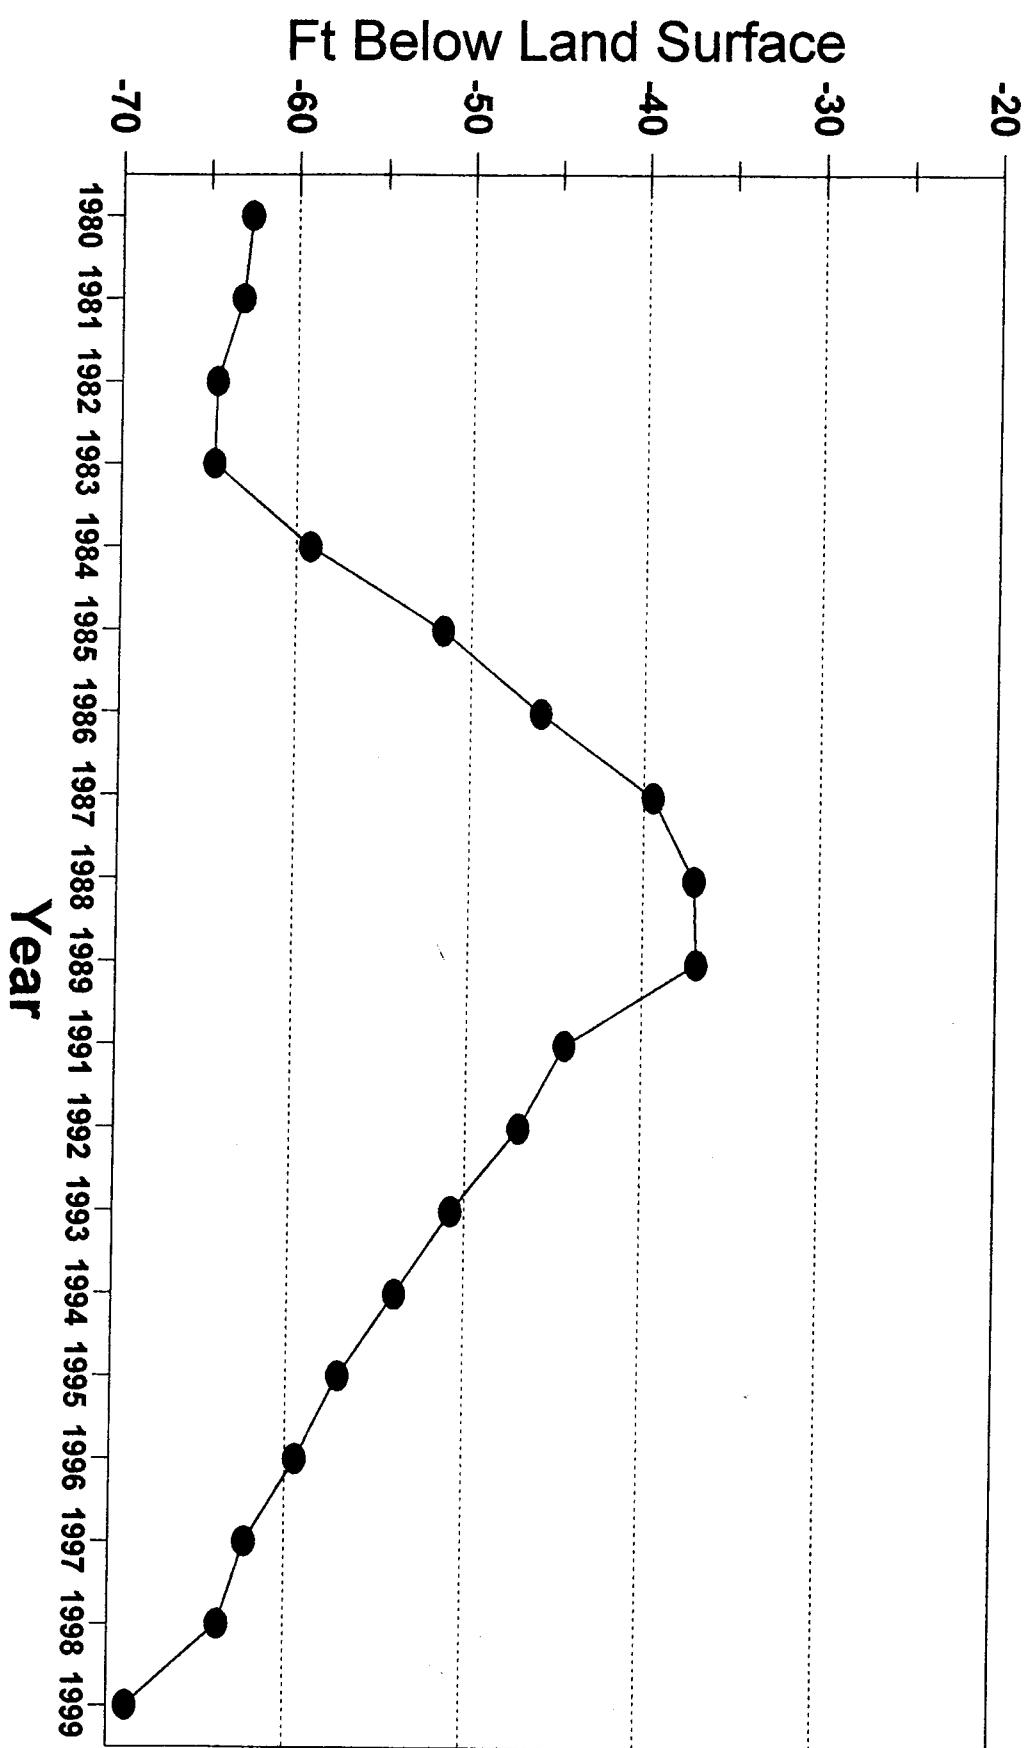
Well (C-20-5)24bad-2 #26

# Pahvant Valley Ground Water Levels

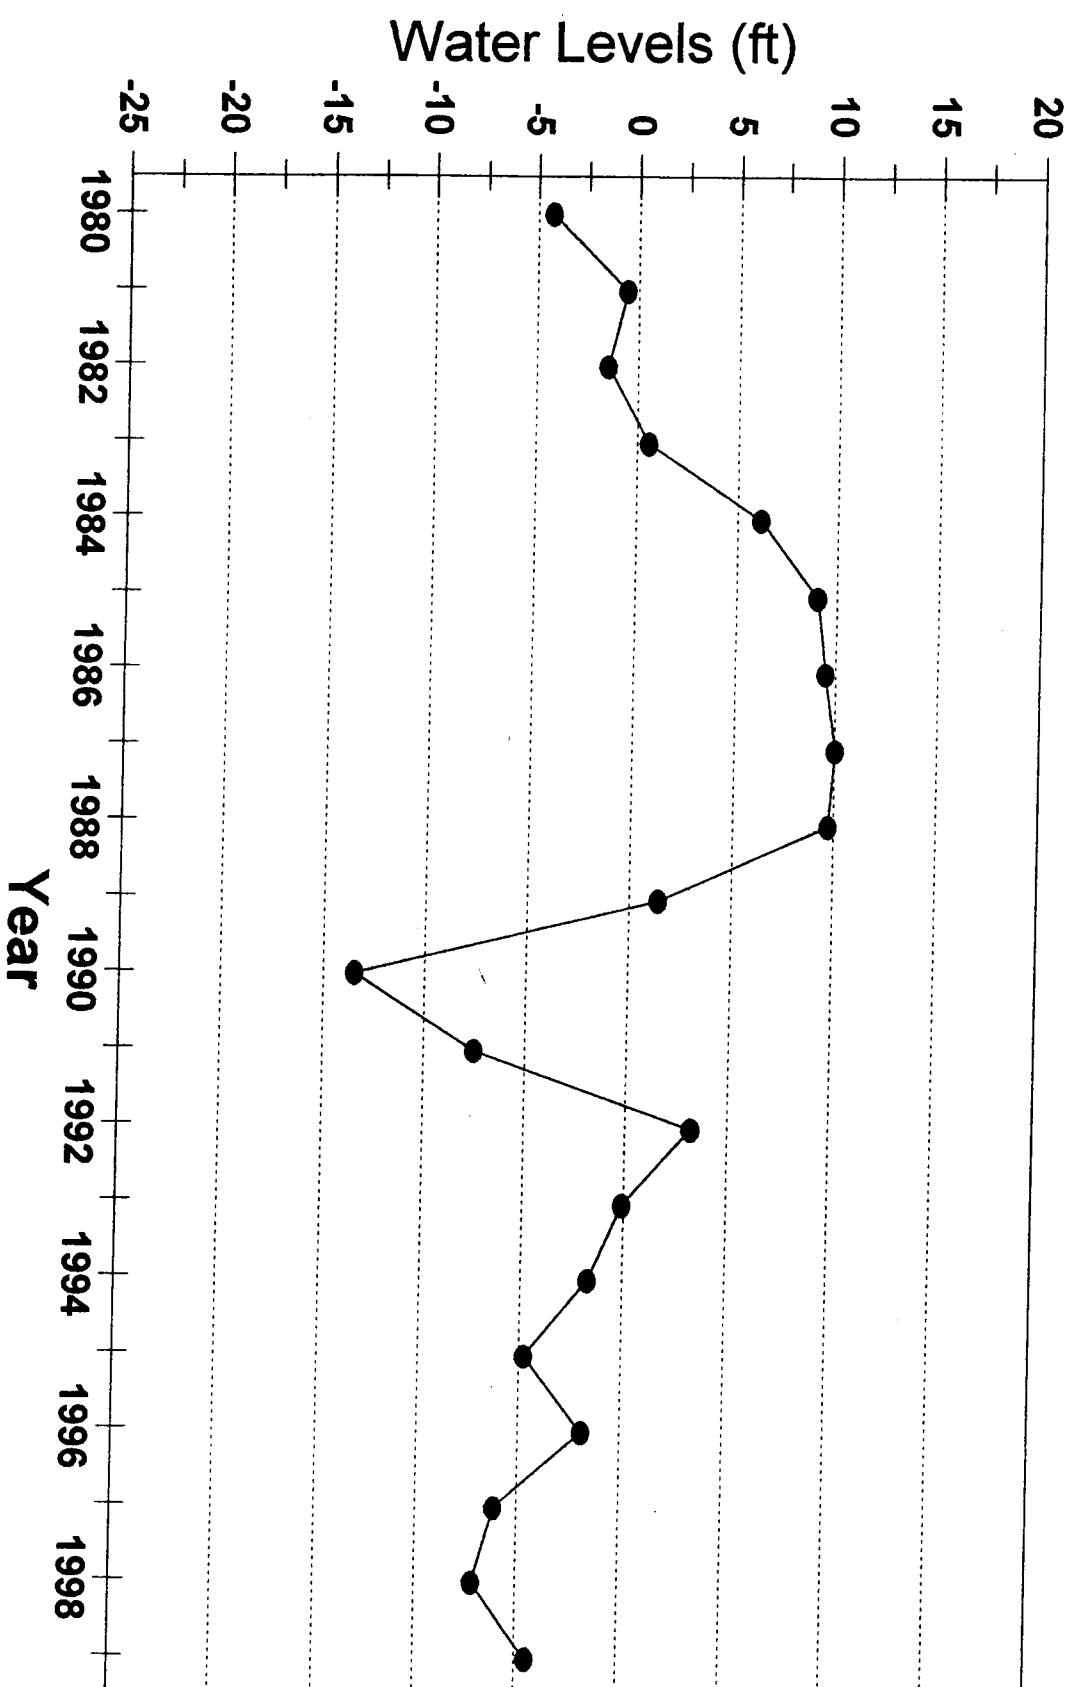
Well (C-20-5)28cdd-1 #31

# Pahvant Valley Ground Water Levels

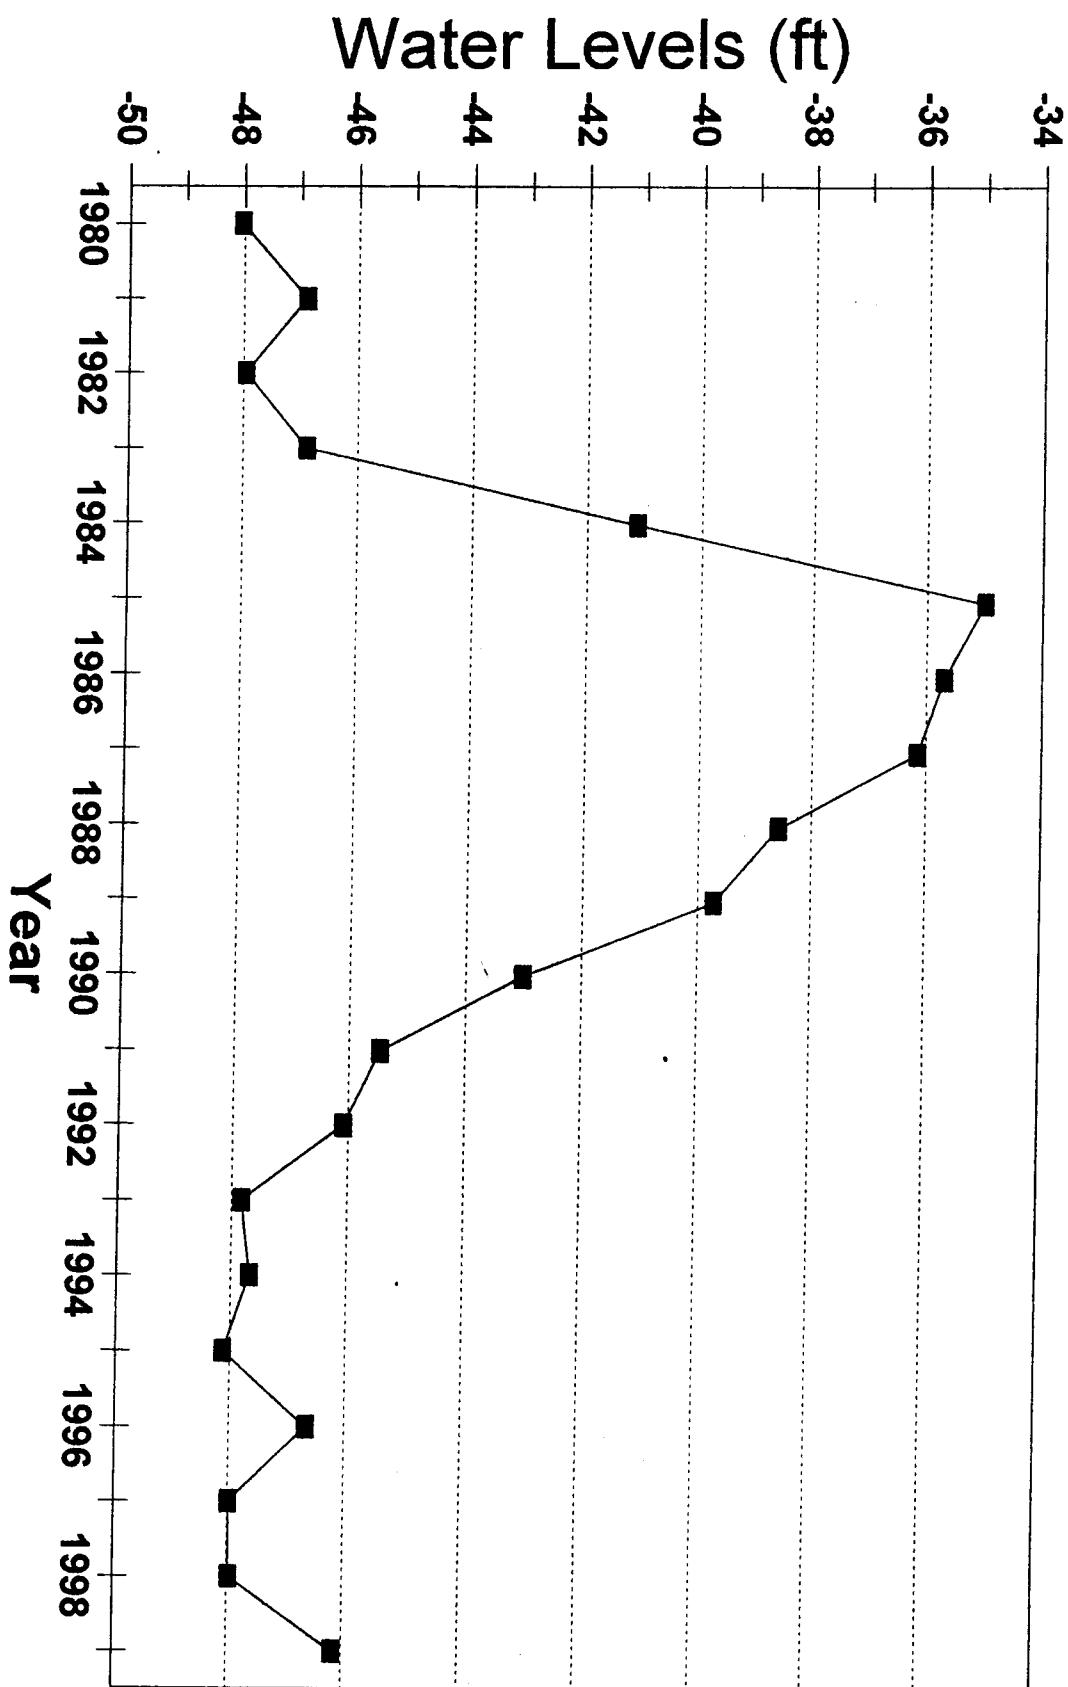
Well (C-21-5)7cdd-3 #37

# Pahvant Valley Ground Water Levels

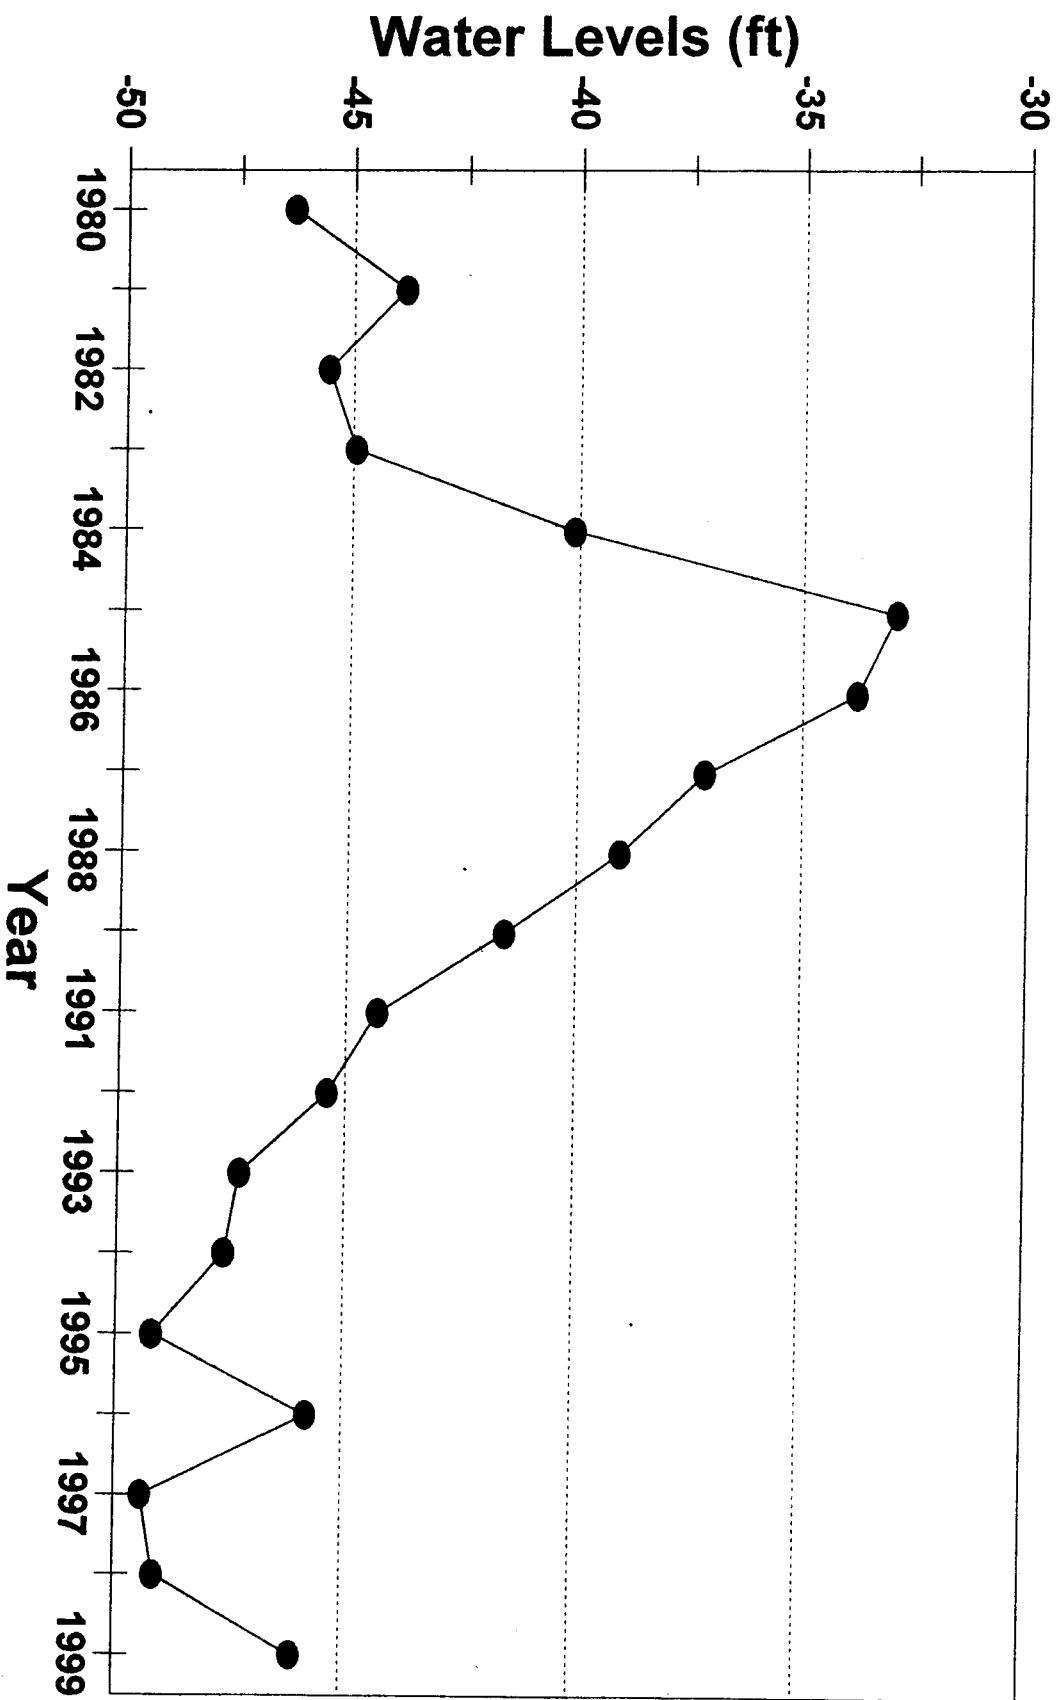
Well (C-21-5)8dbb-2 #40

# Pahvant Valley Ground Water Levels

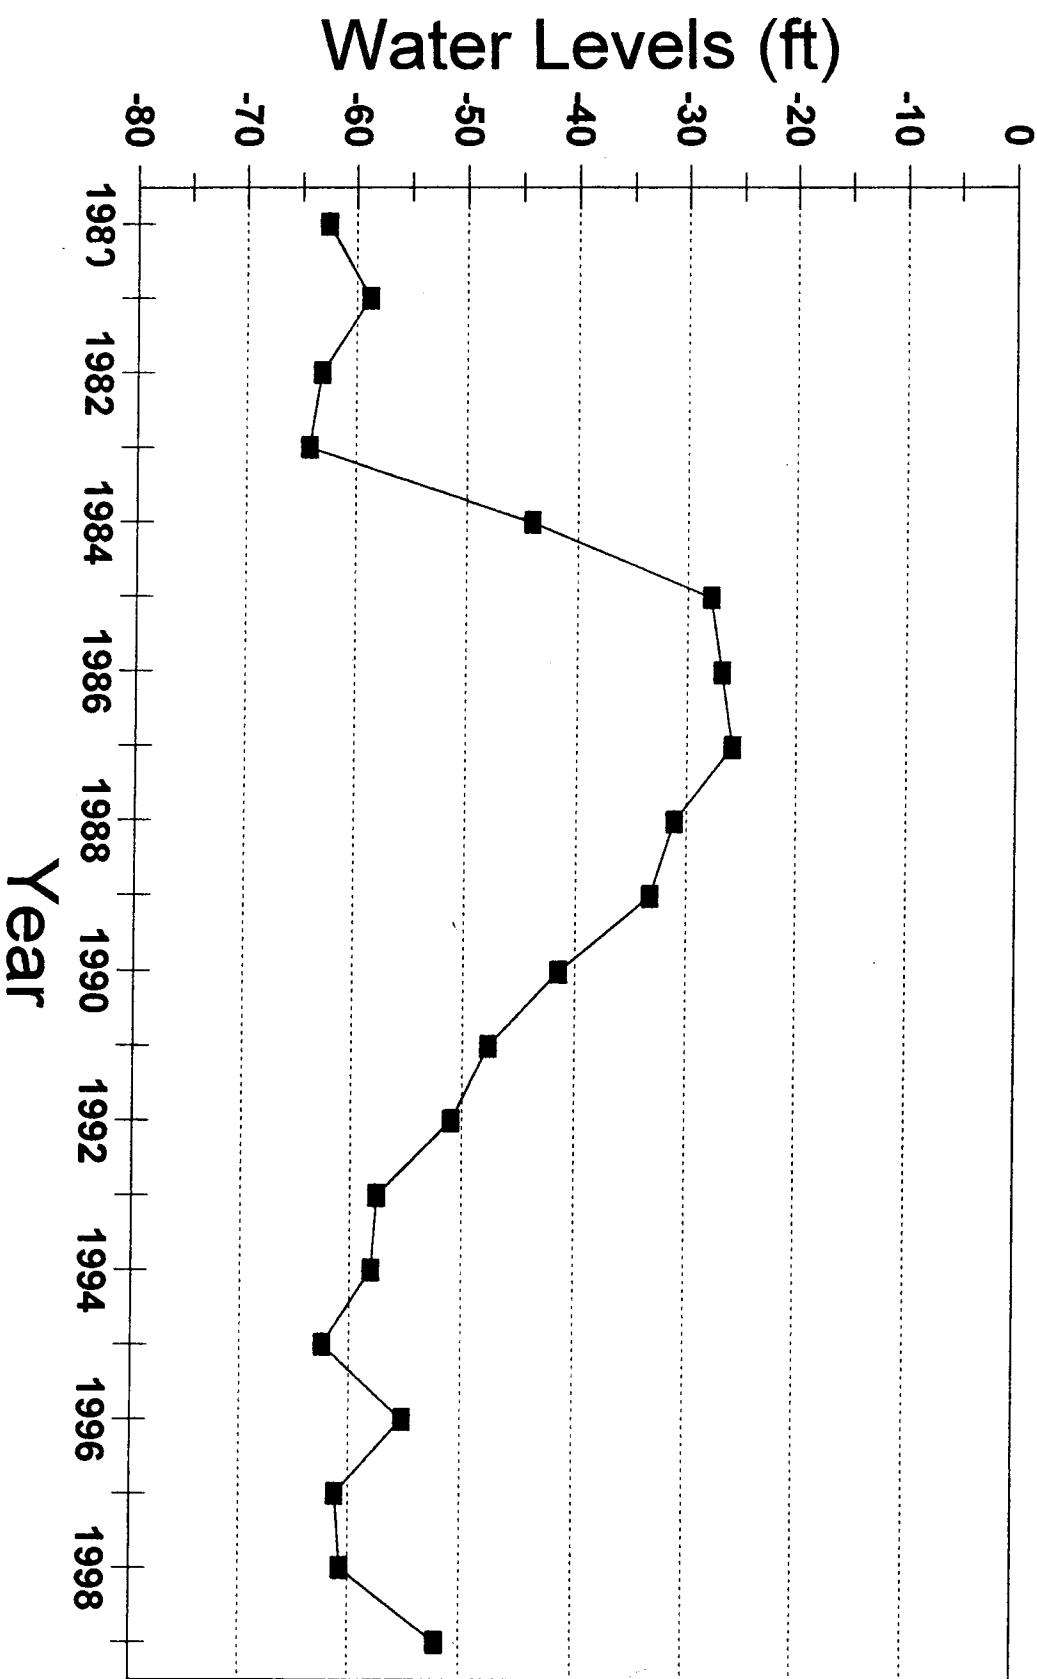
Well (C-22-5)28dbd-1 #58

# Pahvant Valley Ground Water Levels

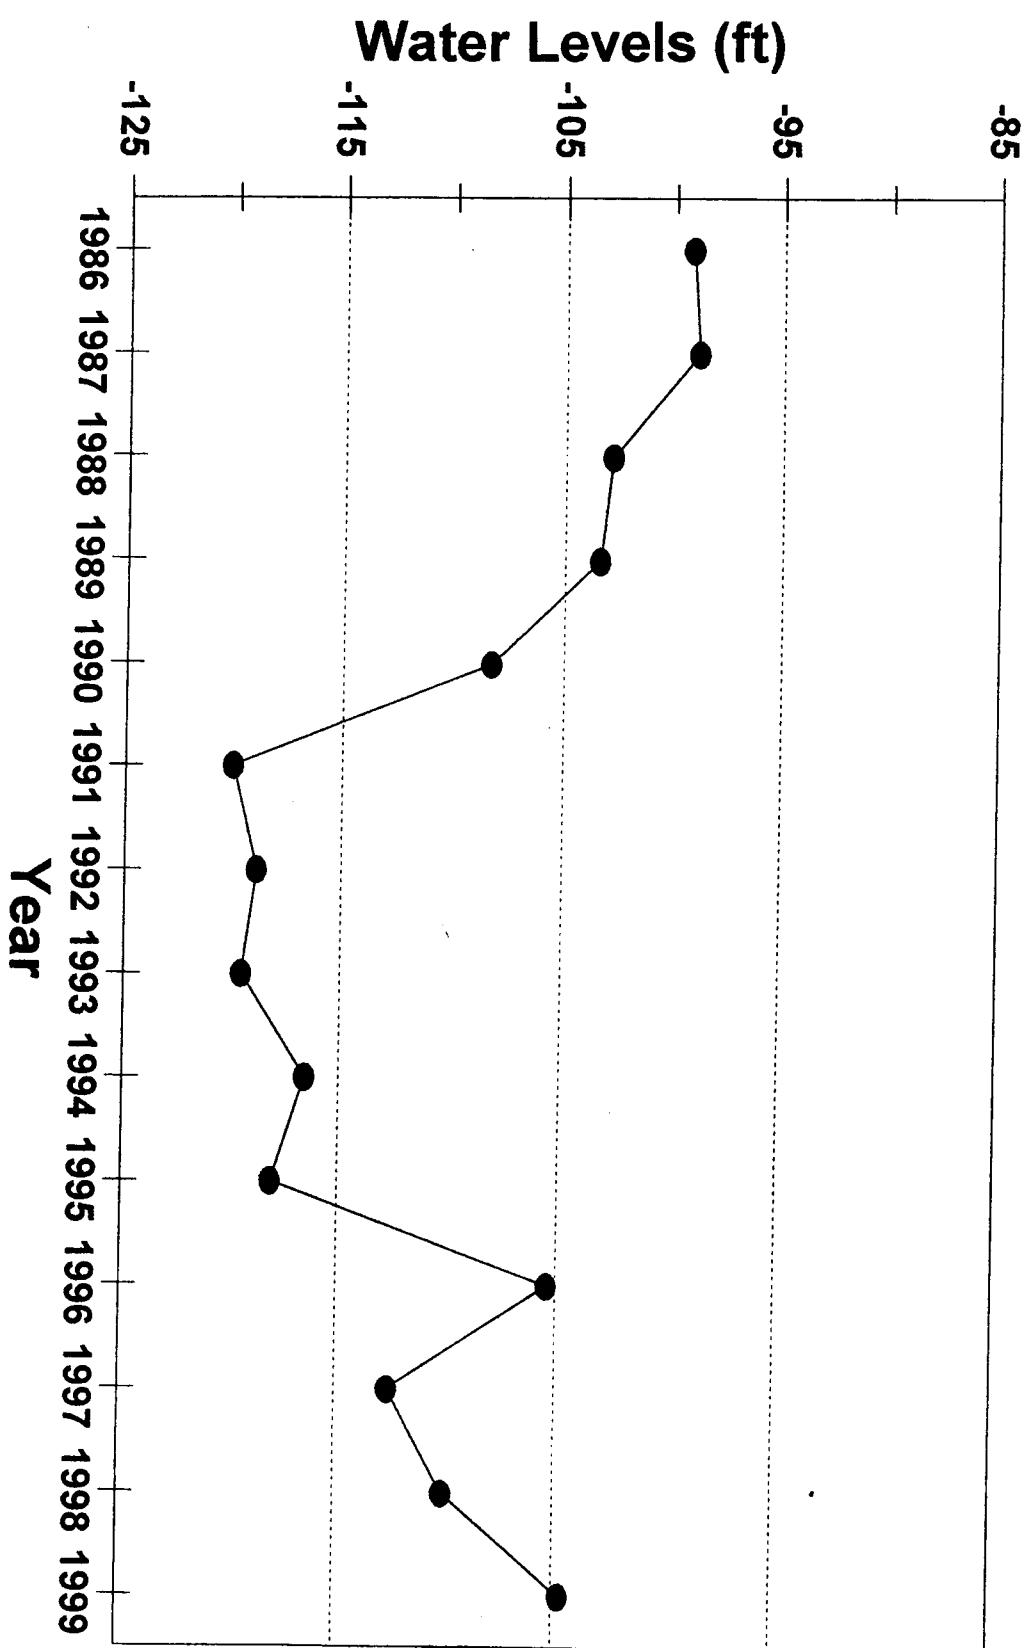
Well (C-23-6)13ddd-1 #78

# Pahvant Valley Ground Water Levels

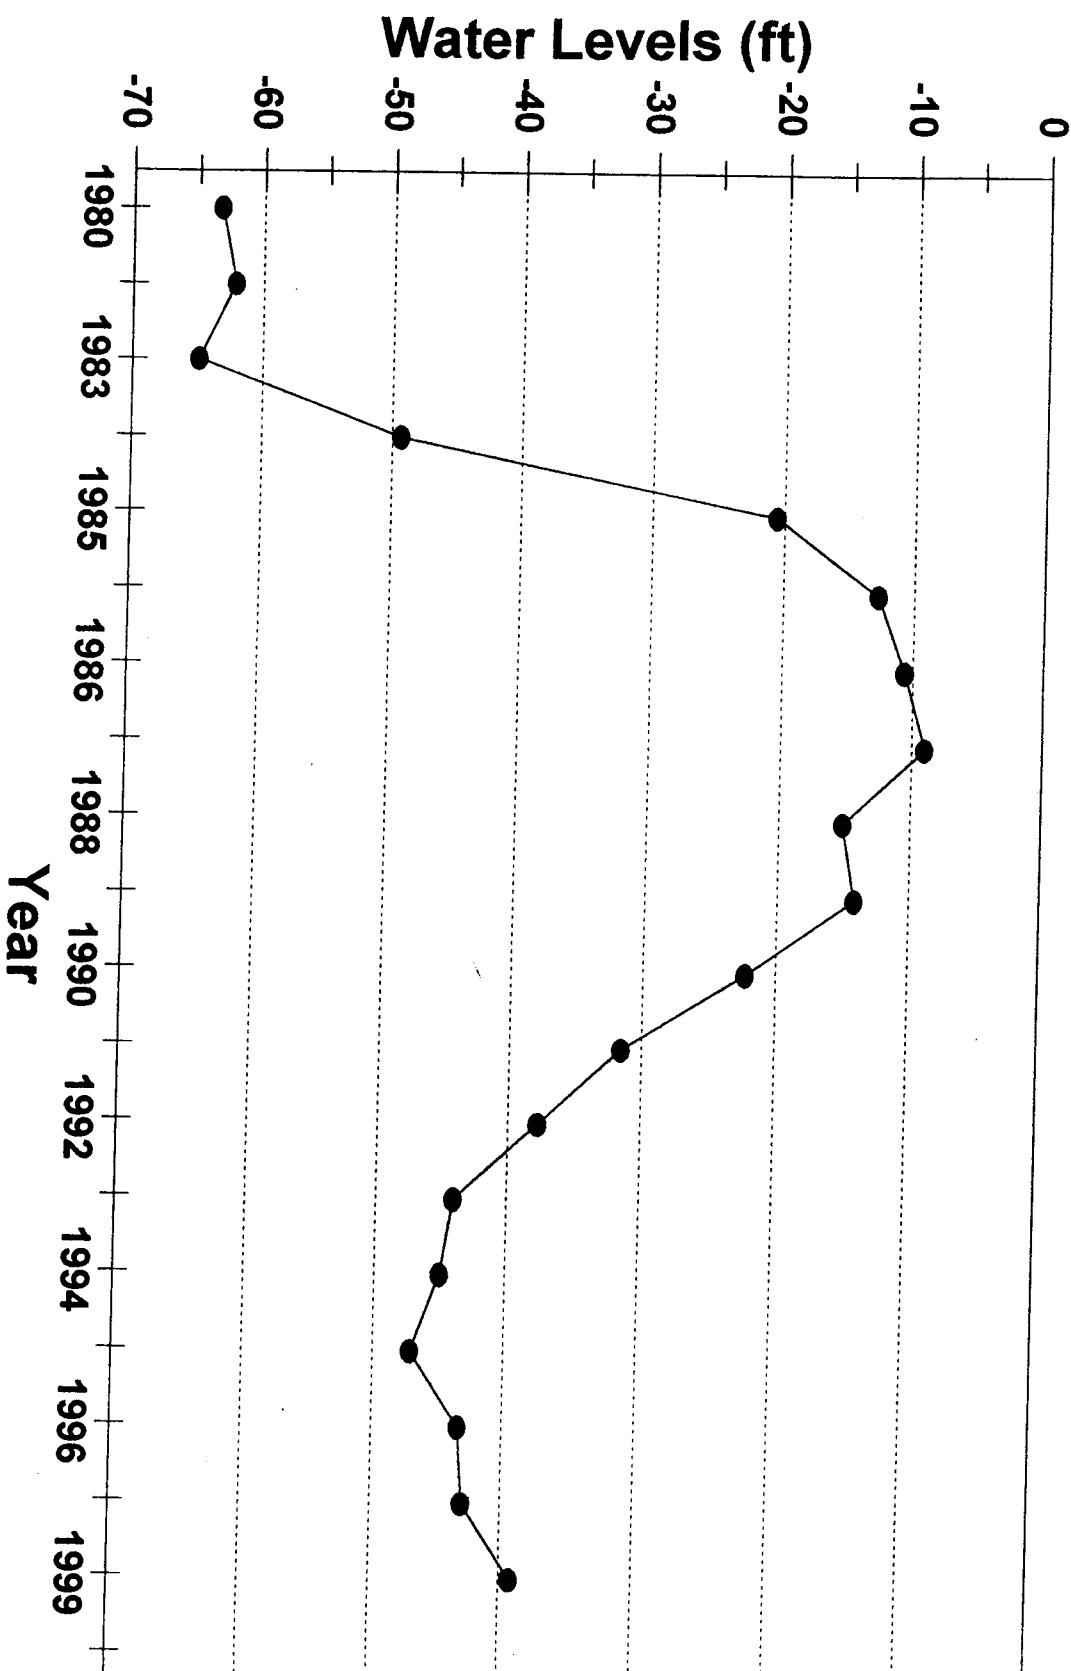
Well (C-23-6) 16cda-1 #81

# Pahvant Valley Ground Water Levels

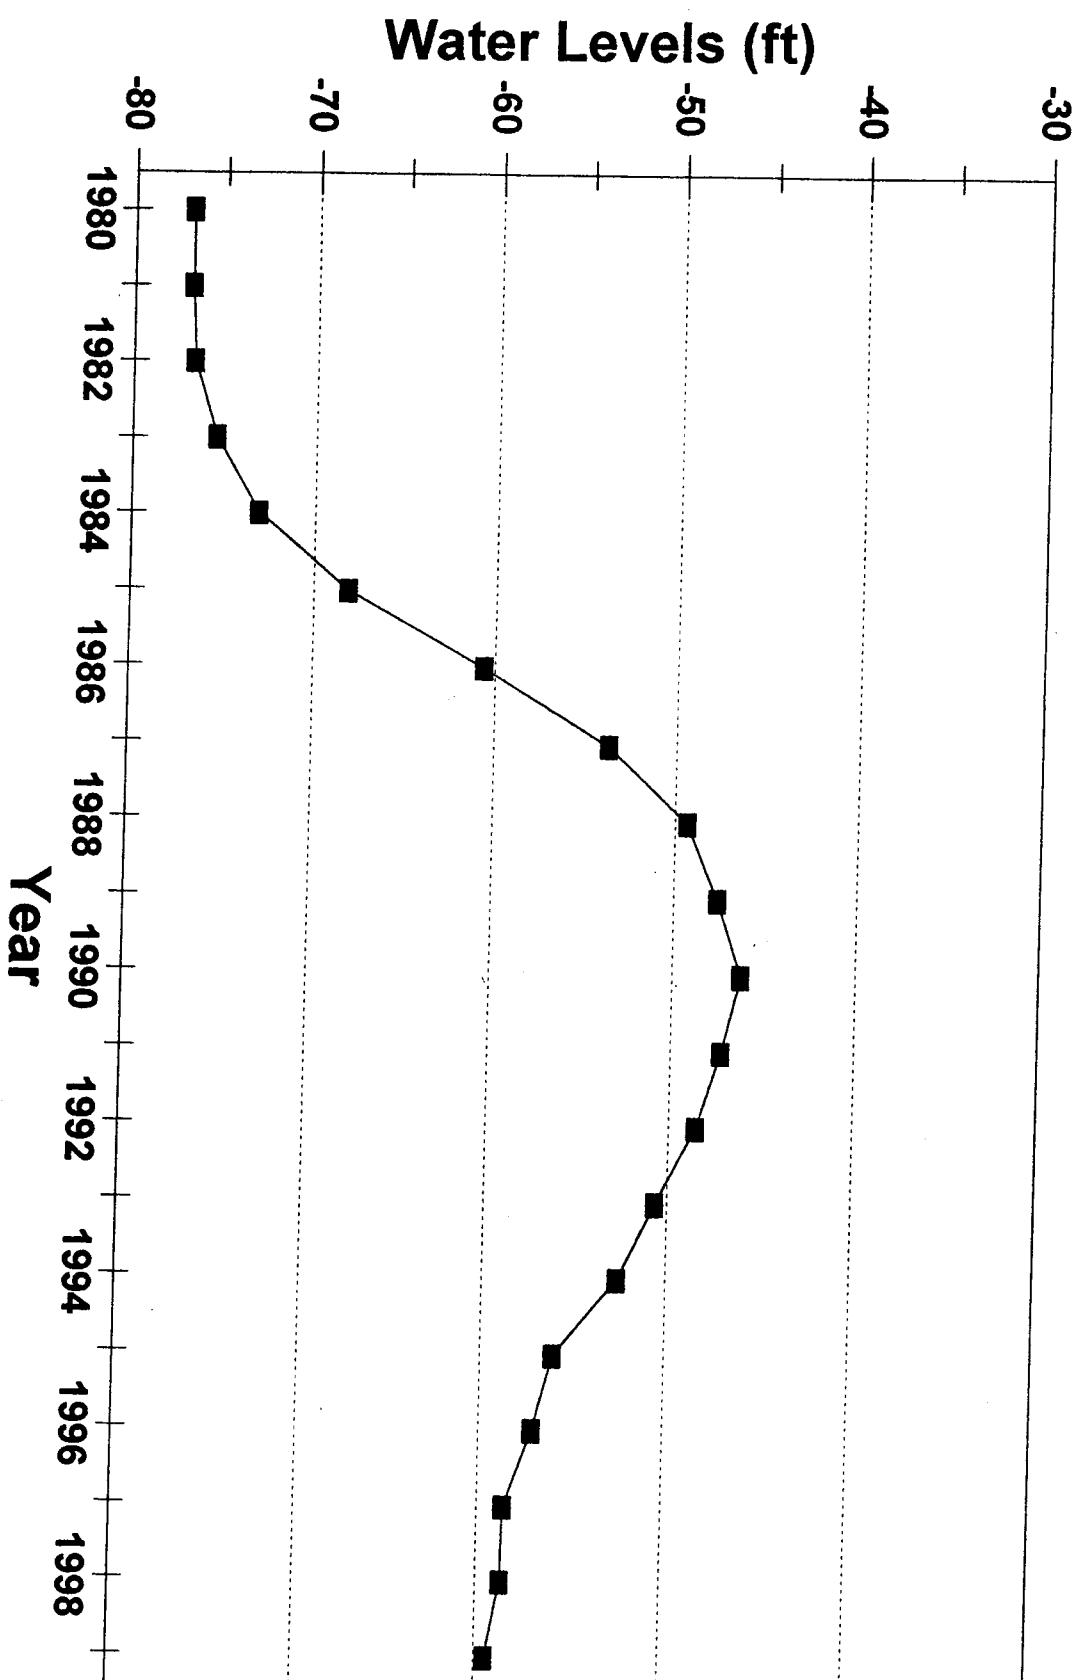
Well (C-23-6)20bda-1 #87

# Pahvant Valley Ground Water Levels
